## **FIRE RISK ASSESSMENT – MATHEMATICS BUILDING (INCLUDING OLD OCEANOGRAPHY BUILDING)**

**Responsible person:** University of Liverpool

**Assessor:** Steve Dunkley

**Date of assessment:** May 2017

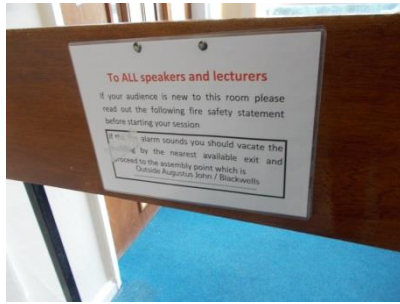
The last time a fire drill was carried out was February 2017 (again this was not a successful evacuation and took over 10 minutes to complete). If not already done so, this needs to be raised with the Head of Mathematics who must take some positive action to ensure staff and students responds more quickly in future evacuations.

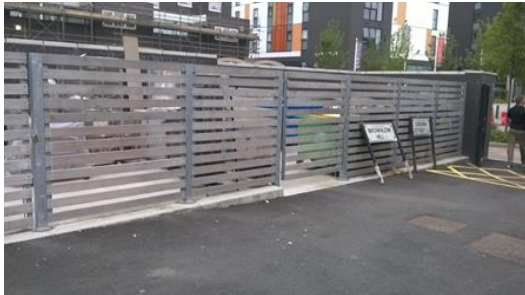
There used to be two main storage areas for bins both near the perimeter of the building. However, since the last assessment a new dedicated bin store set well away from the building has been built.

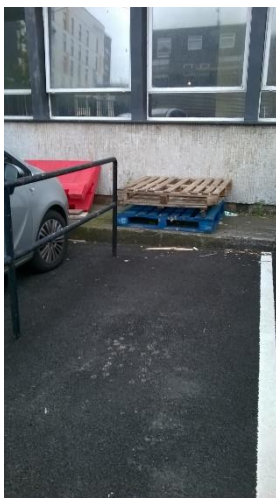
Generally, the perimeter around the two blocks was kept in good order although there were a couple of wooden pallets left near the building opposite the bin store.

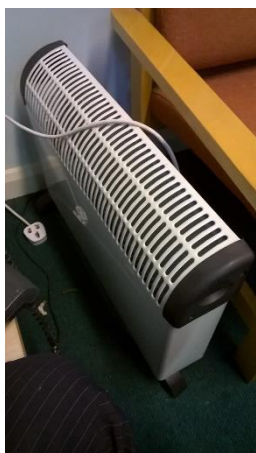
The main heating system is checked and maintained by FRCS. Heating in the building did not seem to be a major issue however there were one or two areas that had portable heaters available for use. The only portable heaters seen in use were the convector type – this is in accordance with University guidance which only recommends the use of convector or oil filled heaters. NB - University Policy states that radiant bar heaters or LPG heaters are not permitted.

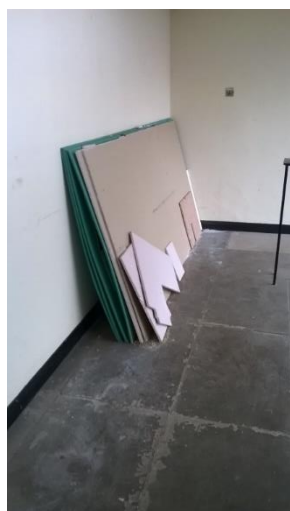
Boards have been left in the north end staircase, ground floor. These need to be removed.

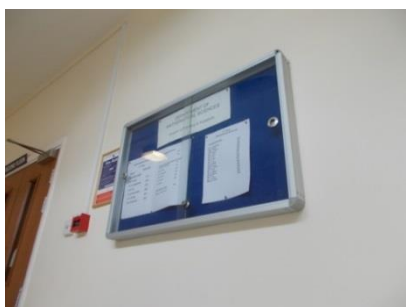
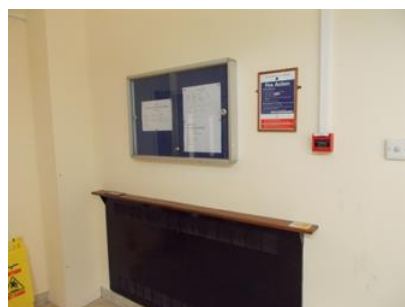
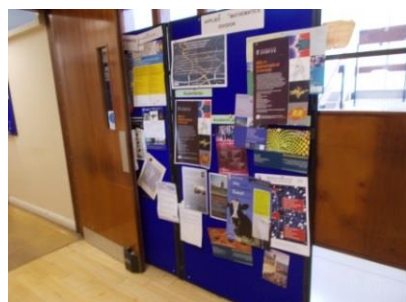
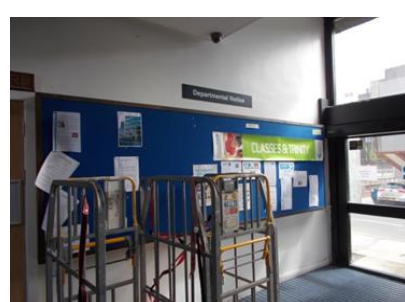
There was still some work to do in other areas particularly the foyer and dead end corridors. Here noticeboards in use were still of the open faced type. As monies become available these should be upgraded to a fire resistant version.

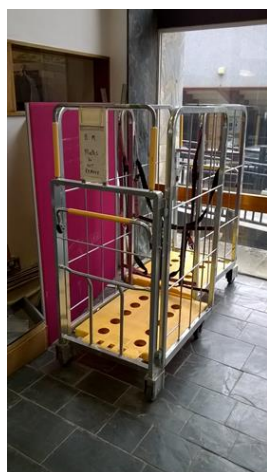
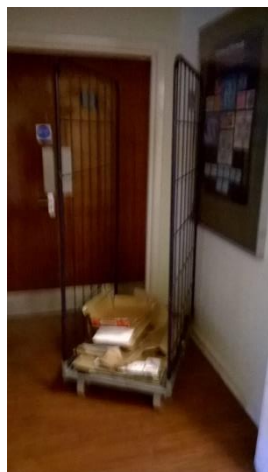
Cages for cardboard were still being stored in the main foyer area. As this is likely to be the main escape route, combustibles in this area should be kept to a minimum. Alternative storage areas for cages containing cardboard should be found. Another cage with cardboard in was found in the stairwell outside the prospectus store area. Those working in this area must be told that cages are not allowed to be stored on the stairwells.

Storing combustible items under stairwells is not acceptable. Combustible items in the old Oceanography building stairwell must be removed	FRCS/Dept.	High	
Cages for cardboard were still being stored in the main foyer area. As this is likely to be the main escape route, combustibles in this area should be kept to a minimum. Alternative storage areas for cages containing cardboard should be found. Another cage with cardboard in was found in the stairwell outside the prospectus store area. Those working in this area must be told that cages are not allowed to be stored on the stairwells.	Head of Dept./DSC/prospectus area	High	
Boards have been left in the north end staircase, ground floor. These need to be removed.	FRCS	High

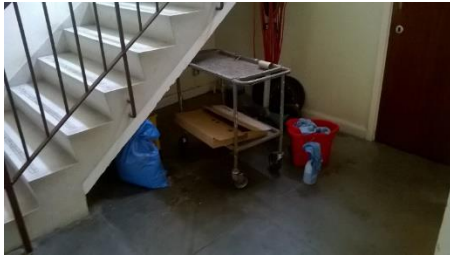
In the old Oceanography building, items were being stored under one of the stairwells. Although most was not combustible, this area should not be seen as a storage place. Escape stairwells should be seen as sterile areas and be kept clear.

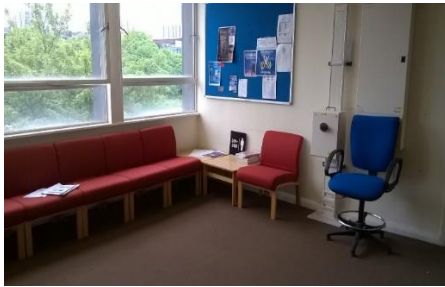
In the main tower, there are parts of the building that have short dead end corridors. These open into small communal spaces (see opposite for example). As a single means of escape, the route should be free from combustibles. Whilst the furniture is likely to offer some resistance in a fire, noticeboards should be class 0 fire resistant and furniture should offer a level of fire resistance.

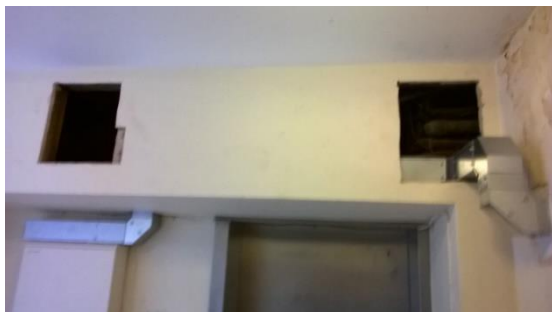
During the assessment, new electrical switchgear had been installed on the north stairwell and some holes were noted. FRCS have confirmed that this equipment will be boxed in with 1 hour fire protection material and locked off.

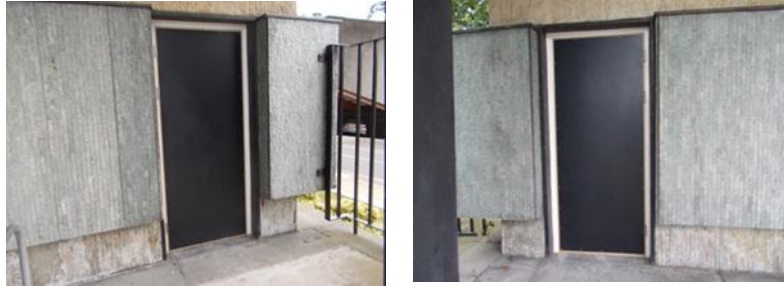
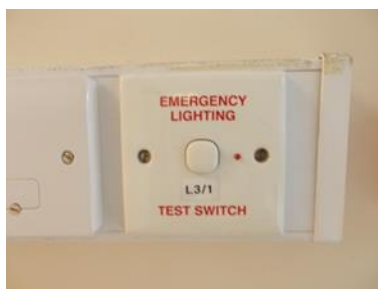
The vast majority of areas were fitted with adequate emergency lighting. This was both on internal stairwells and corridors and on external doors. The only areas where additional lighting was considered necessary was above the doors below (i.e. two single doors out of ground floor lecture theatre (South side) which appeared only to have standard light fittings in the vicinity):

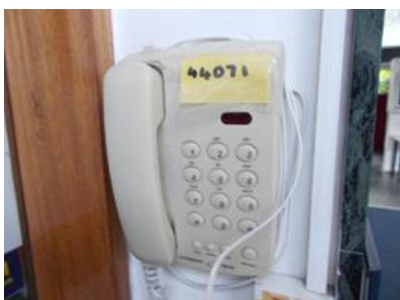
The DSC should check that unless a telephone has a direct emergency number button, all telephones should display the red emergency number sticker.

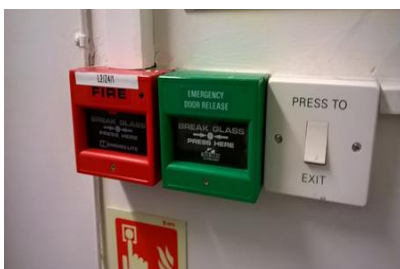
Larger emergency green break glass signs need to be fitted by all emergency door release boxes.
