## **FIRE RISK ASSESSMENT – MATHEMATICS BUILDING (INCLUDING OLD OCEANOGRAPHY BUILDING)**

**Responsible person:** University of Liverpool

**Assessor:** Steve Dunkley

**Date of assessment:** May 2017

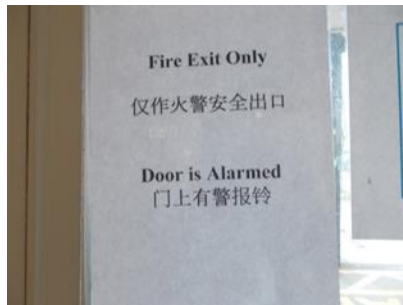
The safety coordinator has commented that a number of foreign students do not seem to appreciate or fully understand the arrangements. To help with this, signs in other languages have been displayed.

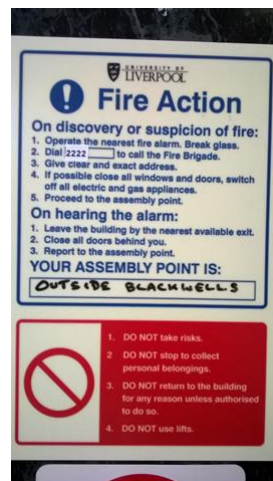
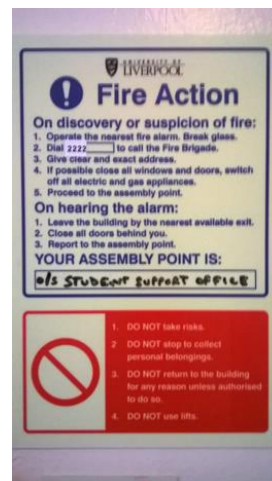
Visitors can ensure they are aware of the arrangements by reading the fire action notices located throughout the building. Users should be able to make themselves familiar with fire procedures, emergency contact numbers and the assembly point. It should be noted that there was conflicting information on some of the fire action notices (see below). The DSC should ensure that a consistent message is being given and that only one assembly point is listed.

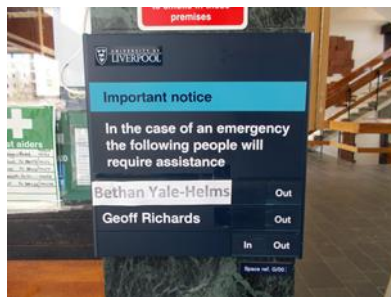
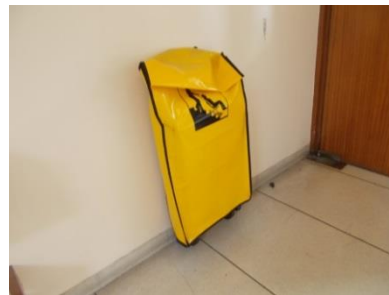
Arrangements are in place to assist anybody with a restrictive mobility issue. Evac chairs are located in the two main stairwells of the tower and a signing in board in use in the main foyer. A team of people have been trained in the chairs use. The DSC is asked to keep a log of those trained and to ensure that an adequate number of people are trained to cover holidays, sickness, etc. The only task that needs to be completed is to fit directional chair signs on the floors where no chair is located (i.e. on the second and fourth). The signs should direct people up to the nearest chair.

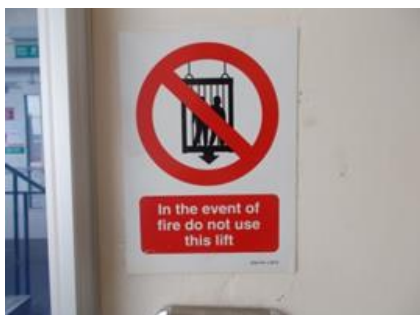
Lifts are not designed to be used in the event of a fire and all are suitably signed.

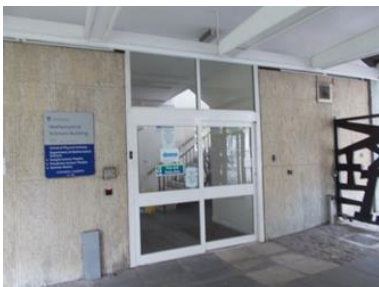
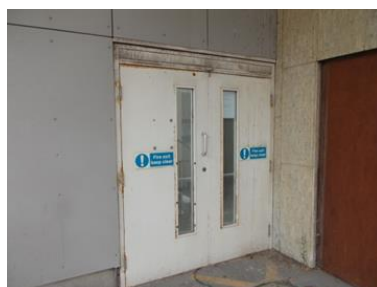
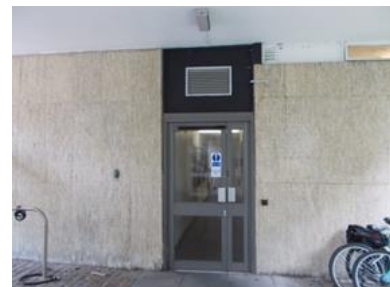
The vast majority of areas were fitted with adequate emergency lighting. This was both on internal stairwells and corridors and on external doors. The only areas where additional lighting was considered necessary was above the doors below (i.e. two single doors out of ground floor lecture theatre (South side) which appeared only to have standard light fittings in the vicinity):

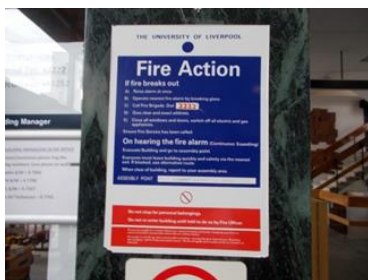
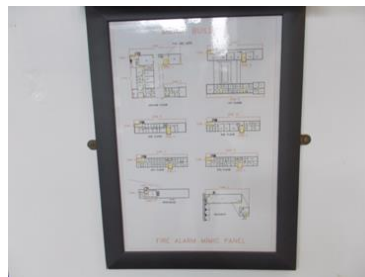
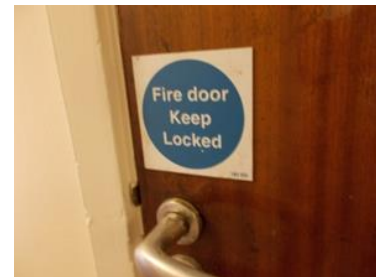
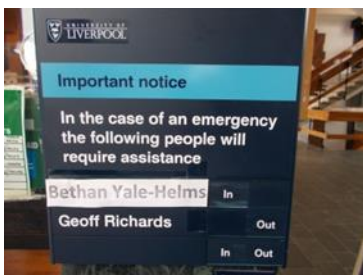
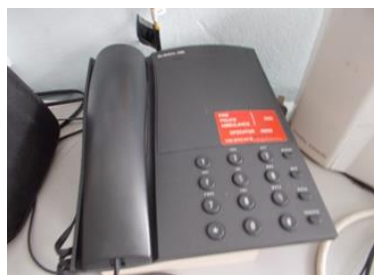
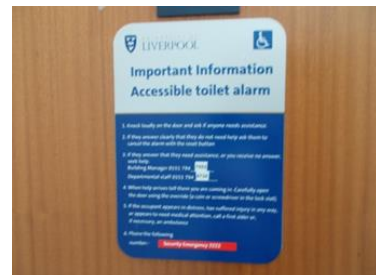
Generally, the standards of signage were good. The panel had a clear mimic diagram to indicate the relevant zones, directional signage was fitted, fire action notices were located near call points and clear mandatory signage was in place for fire doors, etc. Signage for final exit door operation was also fitted and clear. There was evidence of emergency number stickers on telephones and accessible toilets had the standard emergency contact number signs displayed.

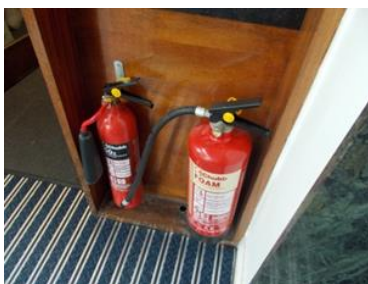
There were an adequate number of fire extinguishers in the two blocks. Normally found in pairs but occasionally as a single unit, they were foam and CO2. It was not considered necessary to provide further extinguishers in the area.

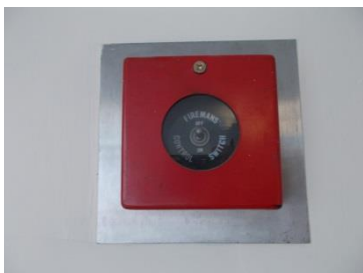
The Fire Service should note that the lift in the North stairwell is fitted with a fireman's control switch.
